AUSTRALIAN GEOGUIDE LR8 (CONSTRUCTION PRACTICE)

HILLSIDE CONSTRUCTION PRACTICE

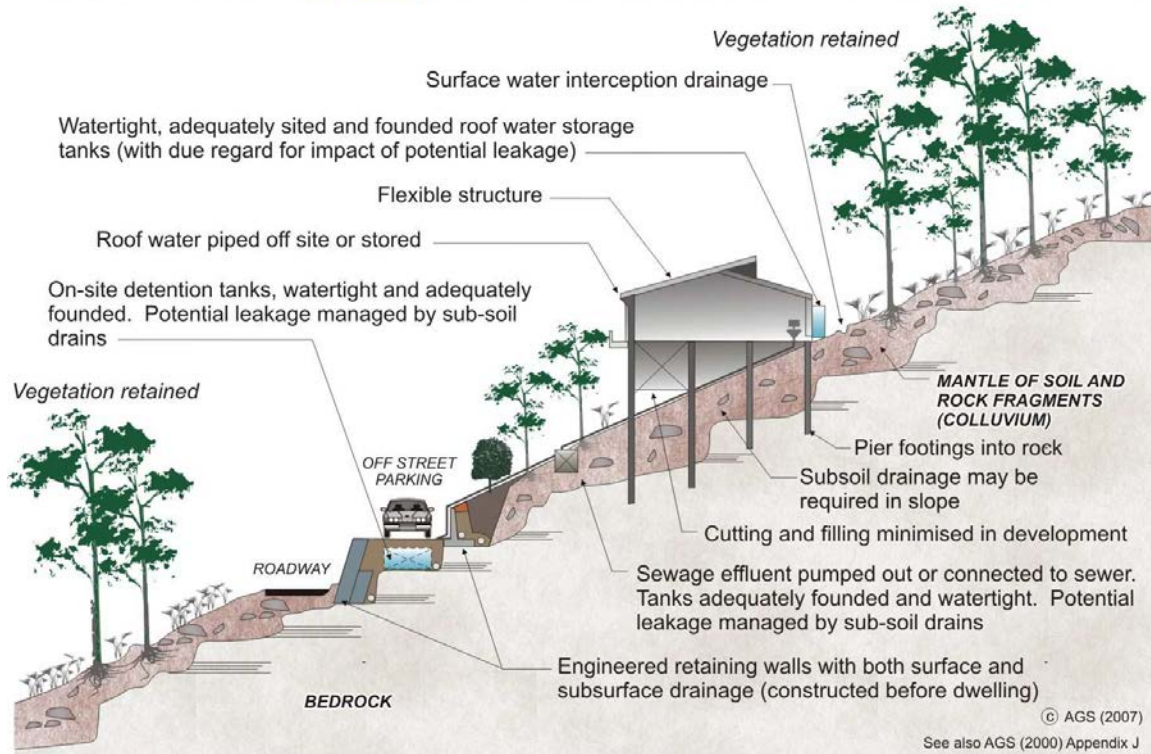
EXAMPLES OF GOOD HILLSIDE CONSTRUCTION PRACTICE

Roadways and parking areas - are paved and incorporate kerbs which prevent water discharging straight into the hillside (GeoGuide LR5).

Cuttings - are supported by retaining walls (GeoGuide LR6).

Retaining walls - are engineer designed to withstand the lateral earth pressures and surcharges expected, and include drains to prevent water pressures developing in the backfill. Where the ground slopes steeply down towards the high side of a retaining wall, the disturbing force (see GeoGuide LR6) can be two or more times that in level ground. Retaining walls must be designed taking these forces into account.

Sewage - whether treated or not is either taken away in pipes or contained in properly founded tanks so it cannot soak into the ground.

Surface water - from roofs and other hard surfaces is piped away to a suitable discharge point rather than being allowed to infiltrate into the ground. Preferably, the discharge point will be in a natural creek where ground water exits, rather than enters, the ground. Shallow, lined, drains on the surface can fulfil the same purpose (GeoGuide LR5).

Surface loads - are minimised. No fill embankments have been built. The house is a lightweight structure. Foundation loads have been taken down below the level at which a landslide is likely to occur and, preferably, to rock. This sort of construction is probably not applicable to soil slopes (GeoGuide LR3). If you are uncertain whether your site has rock near the surface, or is essentially a soil slope, you should engage a geotechnical practitioner to find out.

Flexible structures - have been used because they can tolerate a certain amount of movement with minimal signs of distress and maintain their functionality.

Vegetation clearance - on soil slopes has been kept to a reasonable minimum. Trees, and to a lesser extent smaller vegetation, take large quantities of water out of the ground every day. This lowers the ground water table, which in turn helps to maintain the stability of the slope. Large scale clearing can result in a rise in water table with a consequent increase in the likelihood of a landslide (GeoGuide LR5). An exception may have to be made to this rule on steep rock slopes where trees have little effect on the water table, but their roots pose a landslide hazard by dislodging boulders.

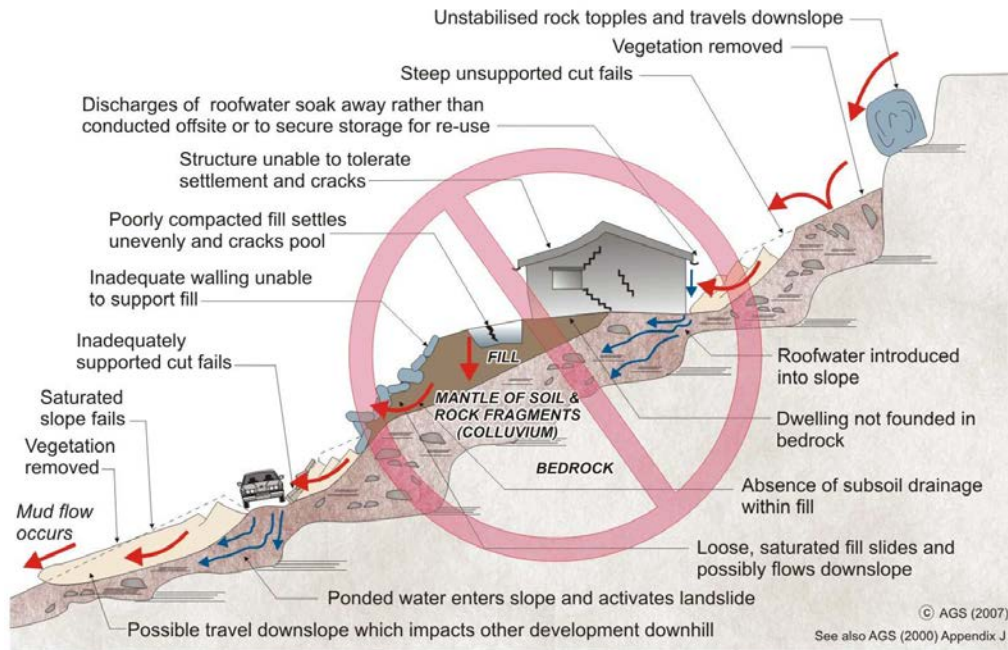
EXAMPLES OF **POOR** HILLSIDE CONSTRUCTION PRACTICE

Roadways and parking areas - are unsurfaced and lack proper table drains (gutters) causing surface water to pond and soak into the ground.

Cut and fill - has been used to balance earthworks quantities and level the site leaving unstable cut faces and added large surface loads to the ground. Failure to compact the fill properly has led to settlement, which will probably continue for several years after completion. The house and pool have been built on the fill and have settled with it and cracked. Leakage from the cracked pool and the applied surface loads from the fill have combined to cause landslides.

Retaining walls - have been avoided, to minimise cost, and hand placed rock walls used instead. Without applying engineering design principles, the walls have failed to provide the required support to the ground and have failed, creating a very dangerous situation.

A heavy, rigid, house - has been built on shallow, conventional, footings. Not only has the brickwork cracked because of the resulting ground movements, but it has also become involved in a man-made landslide.

Soak-away drainage - has been used for sewage and surface water run-off from roofs and pavements. This water soaks into the ground and raises the water table (GeoGuide LR5). Subsoil drains that run along the contours should be avoided for the same reason. If felt necessary, subsoil drains should run steeply downhill in a chevron, or herring bone, pattern. This may conflict with the requirements for effluent and surface water disposal (GeoGuide LR9) and if so, you will need to seek professional advice.

Rock debris - from landslides higher up on the slope seems likely to pass through the site. Such locations are often referred to by geotechnical practitioners as "debris flow paths". Rock is normally even denser than ordinary fill, so even quite modest boulders are likely to weigh many tonnes and do a lot of damage once they start to roll. Boulders have been known to travel hundreds of metres downhill leaving behind a trail of destruction.

Vegetation - has been completely cleared, leading to a possible rise in the water table and increased landslide risk (GeoGuide LR5).
